Field Service Bulletin F9800_01_01

Products Affected: F9800_01_01

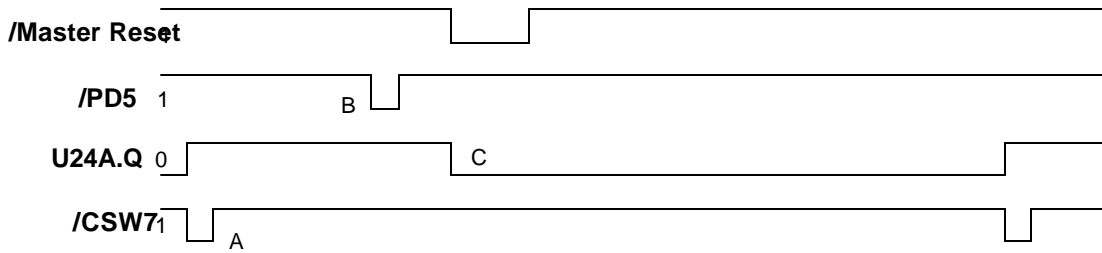
Figure 1

On CPU boards which have not been modified, the /PD5 pulse from the CPU has no effect since U24A is controlling the Master Reset pulse. The signal timing looks like Figure 1.

CPU Board Master Reset Operation Without ECO

- A. /CSW7 becomes active with a series of 10 pulses as the tuning elements are being set up. This series of pulse at this time U24A.Q becomes active (going high).
- B. After the tuning elements have been set up, the CPU issues a pulse on /PD5 to trigger a Master Reset pulse. Since this pulse has no effect.
- C. U24A.Q transitions from high-to-low causing a Master Reset pulse to be generated.

The net effect is that the CPU is no longer controlling the Master Reset pulse. Under normal operation, this is not a problem. The problem occurs when the F-9800 is running its BITE test. Under this condition, there is sometimes a conflict in timing where the Master Reset pulse is still active when the tuning elements are being changed. This causes the elements to be mistuned, which in turn may cause a BITE failure. The problem can sometimes be heard as a “skipping” in the tuning relays during BITE.
